CORRECT FITTING OF THE SPRING GUIDE IN ASG CZ SCORPION EVO 3 A1, CARBINE AND BET MODELS

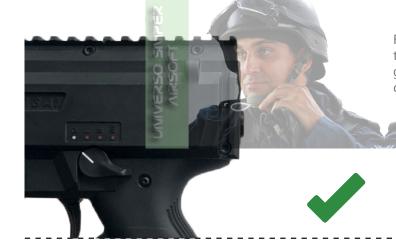
When inserted correctly, the spring guide should protrude approximately 1.5mm from the rear of the receiver, as shown.

Failure to seat the locating tabs in their recesses correctly will cause the spring guide to sit too far into the gearbox shell, allowing the guide to impede the rearward motion of the piston, which may cause damage to your gun.

When installing or reinserting the spring guide, the locating tabs on the guide are inserted and the 12 and 6 o'clock positions. The guide should then be rotated through 90 degrees and the tabs should seat in the internal recesses at the 3 and 9 o'clock positions.
